# Feeder Thinning

At The Point Lepreau NGS

18 Dec 1997

New Brunswick Power

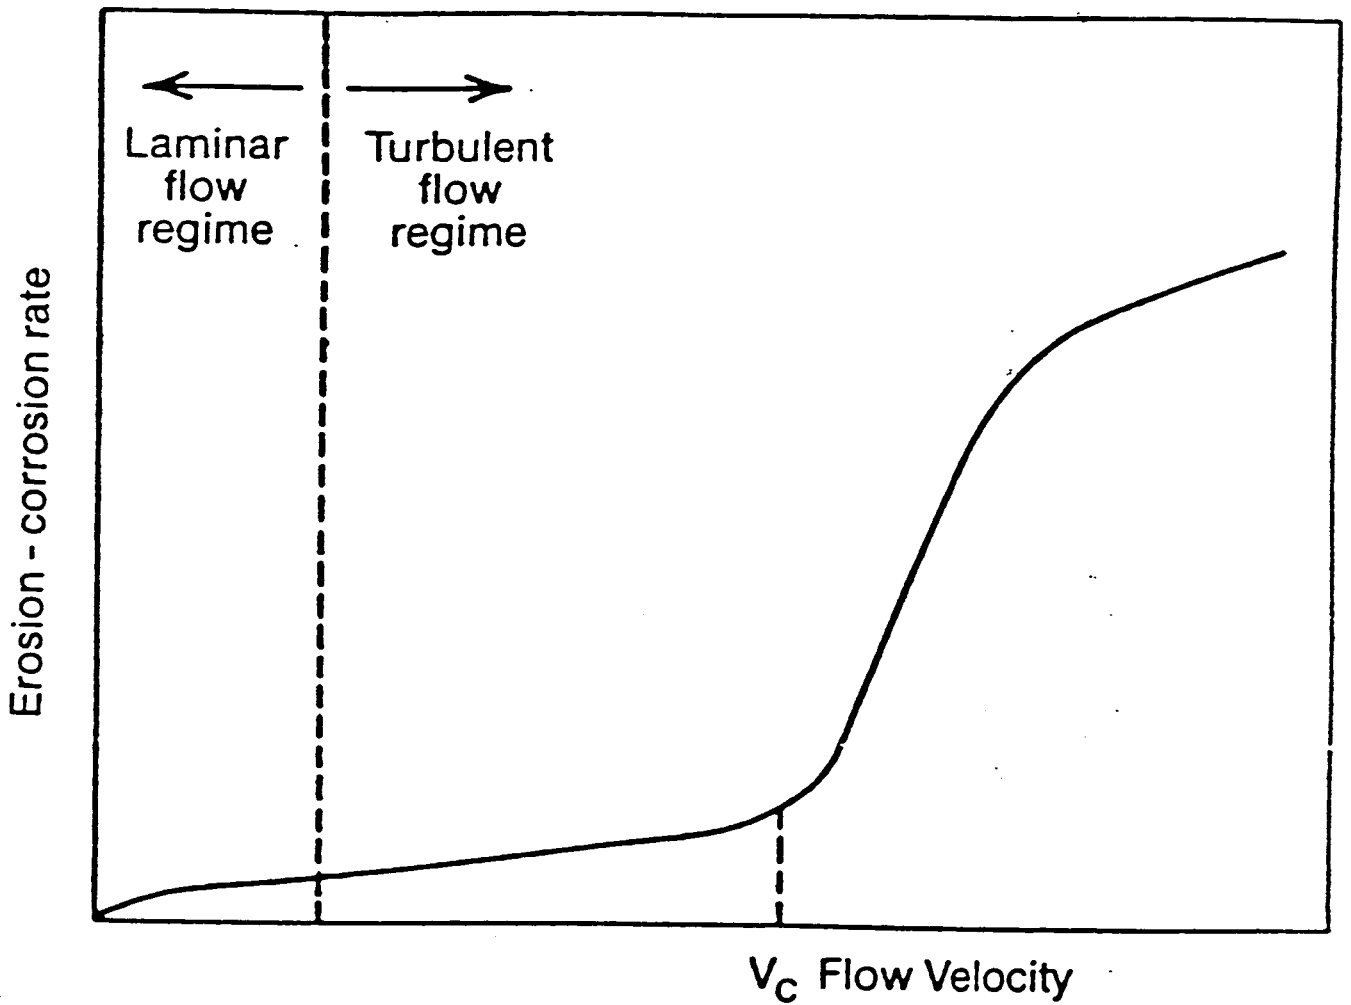
Figure 1 Schematic Showing the Effect of Flow Velocity on Erosion - Corrosion Rate (from Ref. 1).

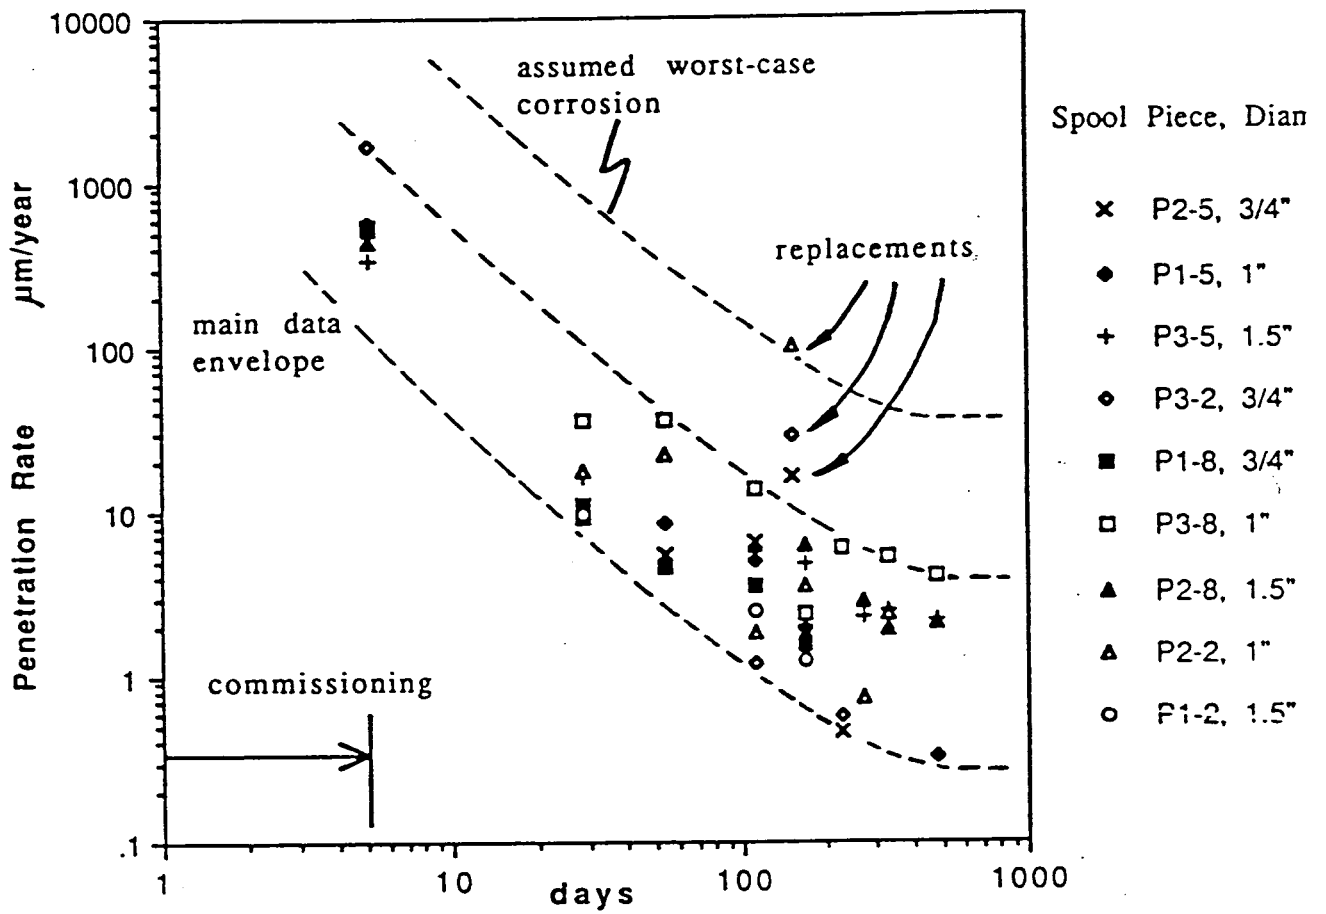
Figure 17 Apparent Average Corrosion Rates of SPEL Spool Pieces Vs Time

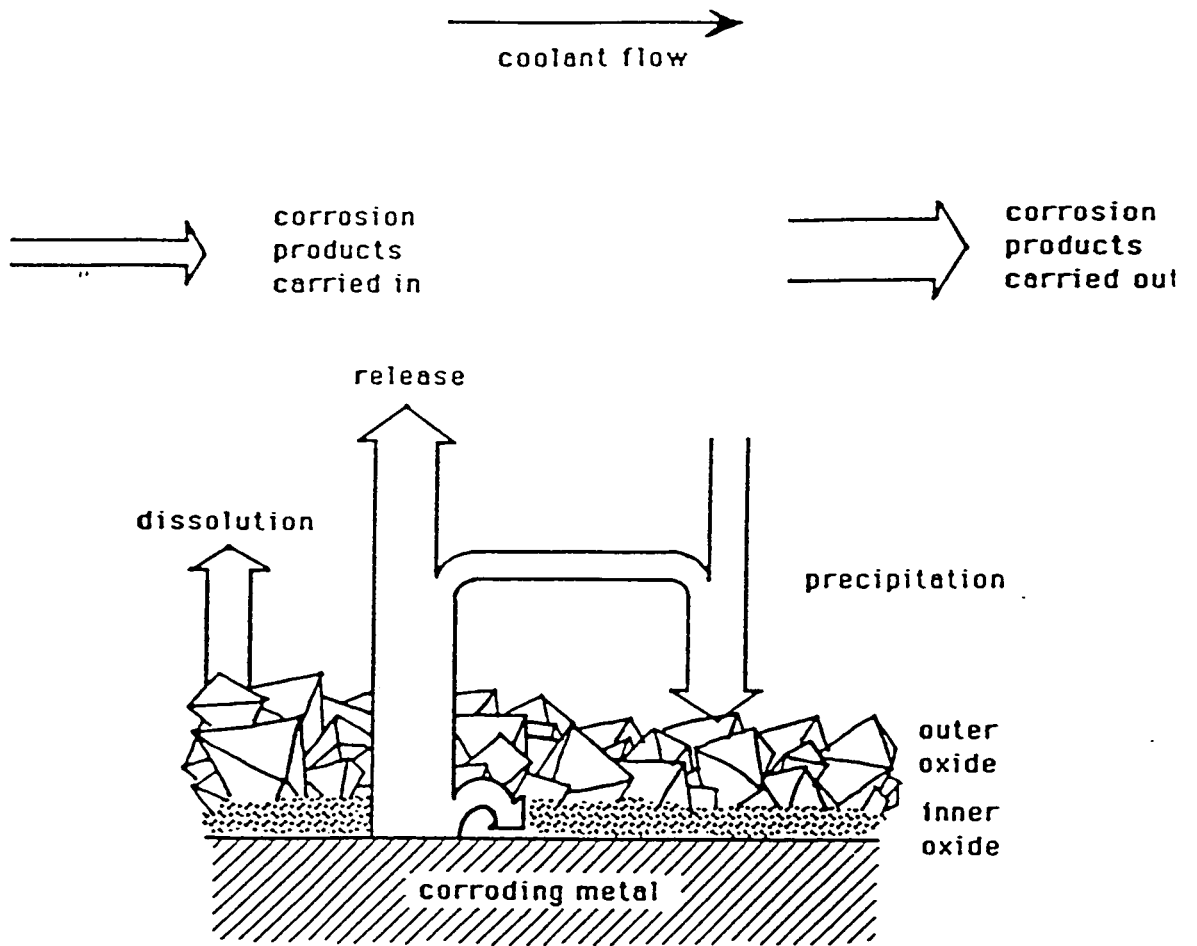
Figure 2 Carbon Steel Corroding Under FAC Conditions.

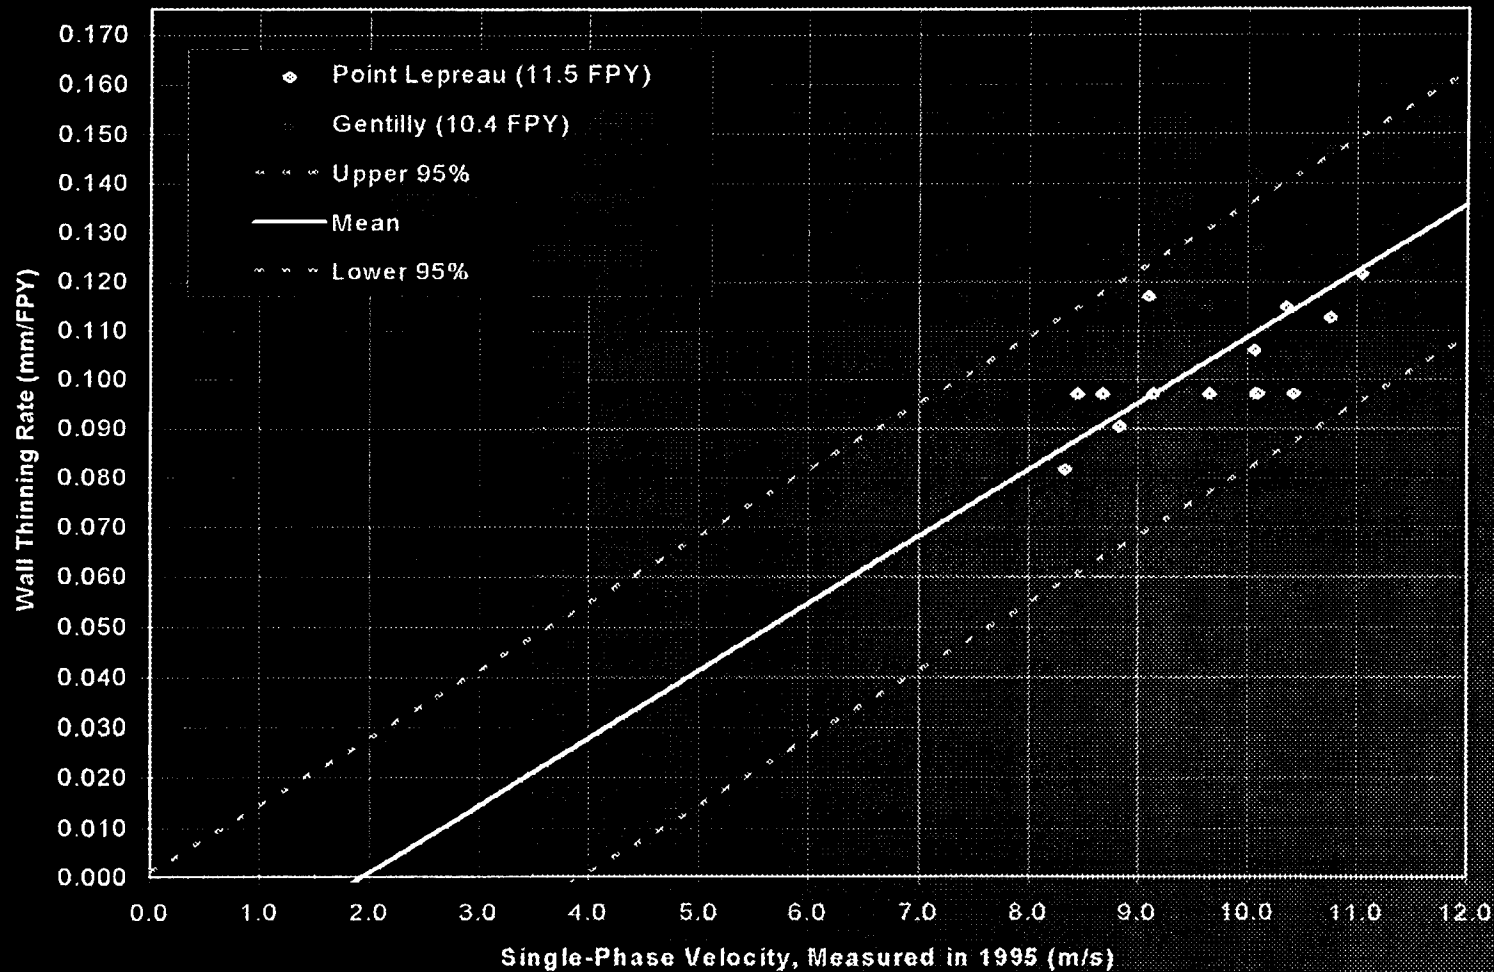
**POINT LEPREAU OUTLET FEEDER WALL THICKNESS  
STATUS REPORT - FALL '97 OUTAGE**

Full Power Years at Shutdown:	13.03 FPY
Number of Feeders Measured this Outage, Baseline:	79 of 175
Number of Feeders Measured this Outage, Repeat:	6 of 7
Total Number Measured, Including Previous Years:	145 of 380

Minimum Measured Thickness for 2" Feeders, Fall '97:	3.53 mm
--	---------

*(Minimum Allowable Thickness is 2.69 mm, the Minimum Measured in 1996 was 3.44 mm)*

Minimum Measured Thickness for 2.5" Feeders, Fall '97:	4.58 mm
--	---------

*(Minimum Allowable Thickness is 3.25 mm, the Minimum Measured in 1996 was 4.71 mm)*
