# APPENDIX 1

### 3.3 The NRX Reactor Accident [15, 16a, 16b, 17, 18]

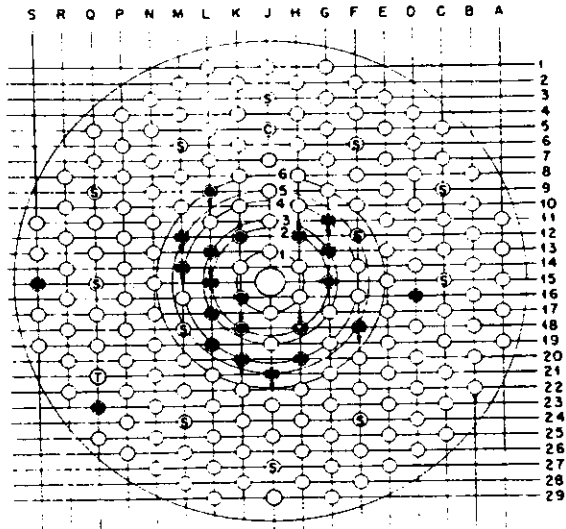
FIG. 3-1 Damaged elements in the NRX core. The plan of the lattice shows rods with abnormal cooling arrangements (indicated by small arrows,  $\uparrow$  = temporary cooling upflow,  $\downarrow$  = temporary cooling downflow); the rod at G-15 is air-cooled. The open circles indicate those rods not ruptured. The black circles with a white annulus (L-9, K-12, G-15, K-16, K-18) are the fresh rods whose outer sheaths were ruptured; similar circles with segmented annulus (e.g., G-11, H-12, M-12) are irradiated rods whose outer sheaths were ruptured. An encircled S, C, and T indicates the position of a shutdown rod, control rod, and thorium rod, respectively.

dicating those elements which ruptured as a result of the accident. At the time of the accident, only one rod (G-15) was air-cooled as mentioned earlier. The only rod which failed in Circle 1 was a fresh rod in K-16. (The parts of a typical fuel-tube system are shown in Fig. 3-2 [16a].) This rod had a small hole in the outer sheath and the calandria tube had a much larger hole. It is surmised that the heat from the very severe rupture of L-15 may have helped to cause the breakdown of K-16. In several instances failure of fuel in one pressure tube caused damage in an adjacent pressure tube. The six rods in Circle 2 were a part of the test being conducted and all were being fed with an upward stream of cooling water with a lower head than usual. As a result, these elements evidently voided first, causing additional local flux increases (in a sense, a local reactivity effect) and causing melting in these elements to be most severe. Other elements with temporary cooling melted shortly thereafter. Damage to some of the normally cooled rods in Circles 3 and 4 appears to indicate that the light water in a number of rods inside Circle 5 was boiling and being expelled by steam. Because of the fuel resistance to the escape of water, the steam pressure built up within the cooling section and at least two rods, M-14 and K-20, broke apart and the upper portions of their shielded sections leaped a foot or so into the air. The air-cooled rod, G-15, which is in Circle 2, the circle of maximum flux, did not damage the calandria tube so far as could be seen. The central parts of the aluminum sheaths melted and ran down the rod, congealing between the calandria tube and the rod. This aluminum formed a barrier on top of which molten uranium formed an

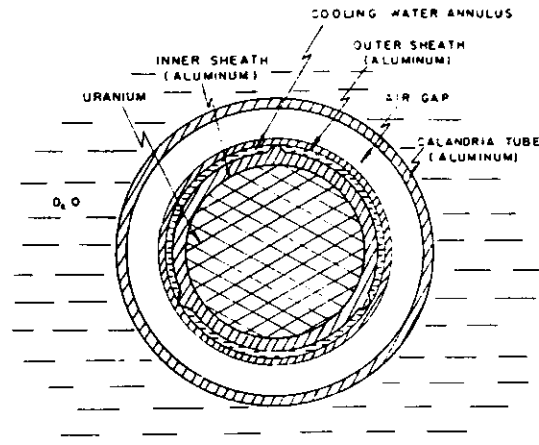
FIG. 3-2 NRX fuel tube cross section. Outer diameter of calandria tube is 2-3/8 in. (6.03 cm).

ingot contained by the calandria tube. At this point, heat transfer between the calandria tube and heavy water apparently preserved the tube itself. Since there was no damage to the calandria tube in this case, it is evident that steam considerably influenced the course of the accident. Steam under pressure in the rods caused the initial rupturing of the outer sheaths. There appeared to be considerable chemical reaction, and not just melting of the materials present. It cannot be decided whether or not the exothermic aluminum water reaction played a significant role. From the analysis, it seems unlikely.
