# Feeder Thinning

At The Point Lepreau NGS

18 Dec 1997

New Brunswick Power

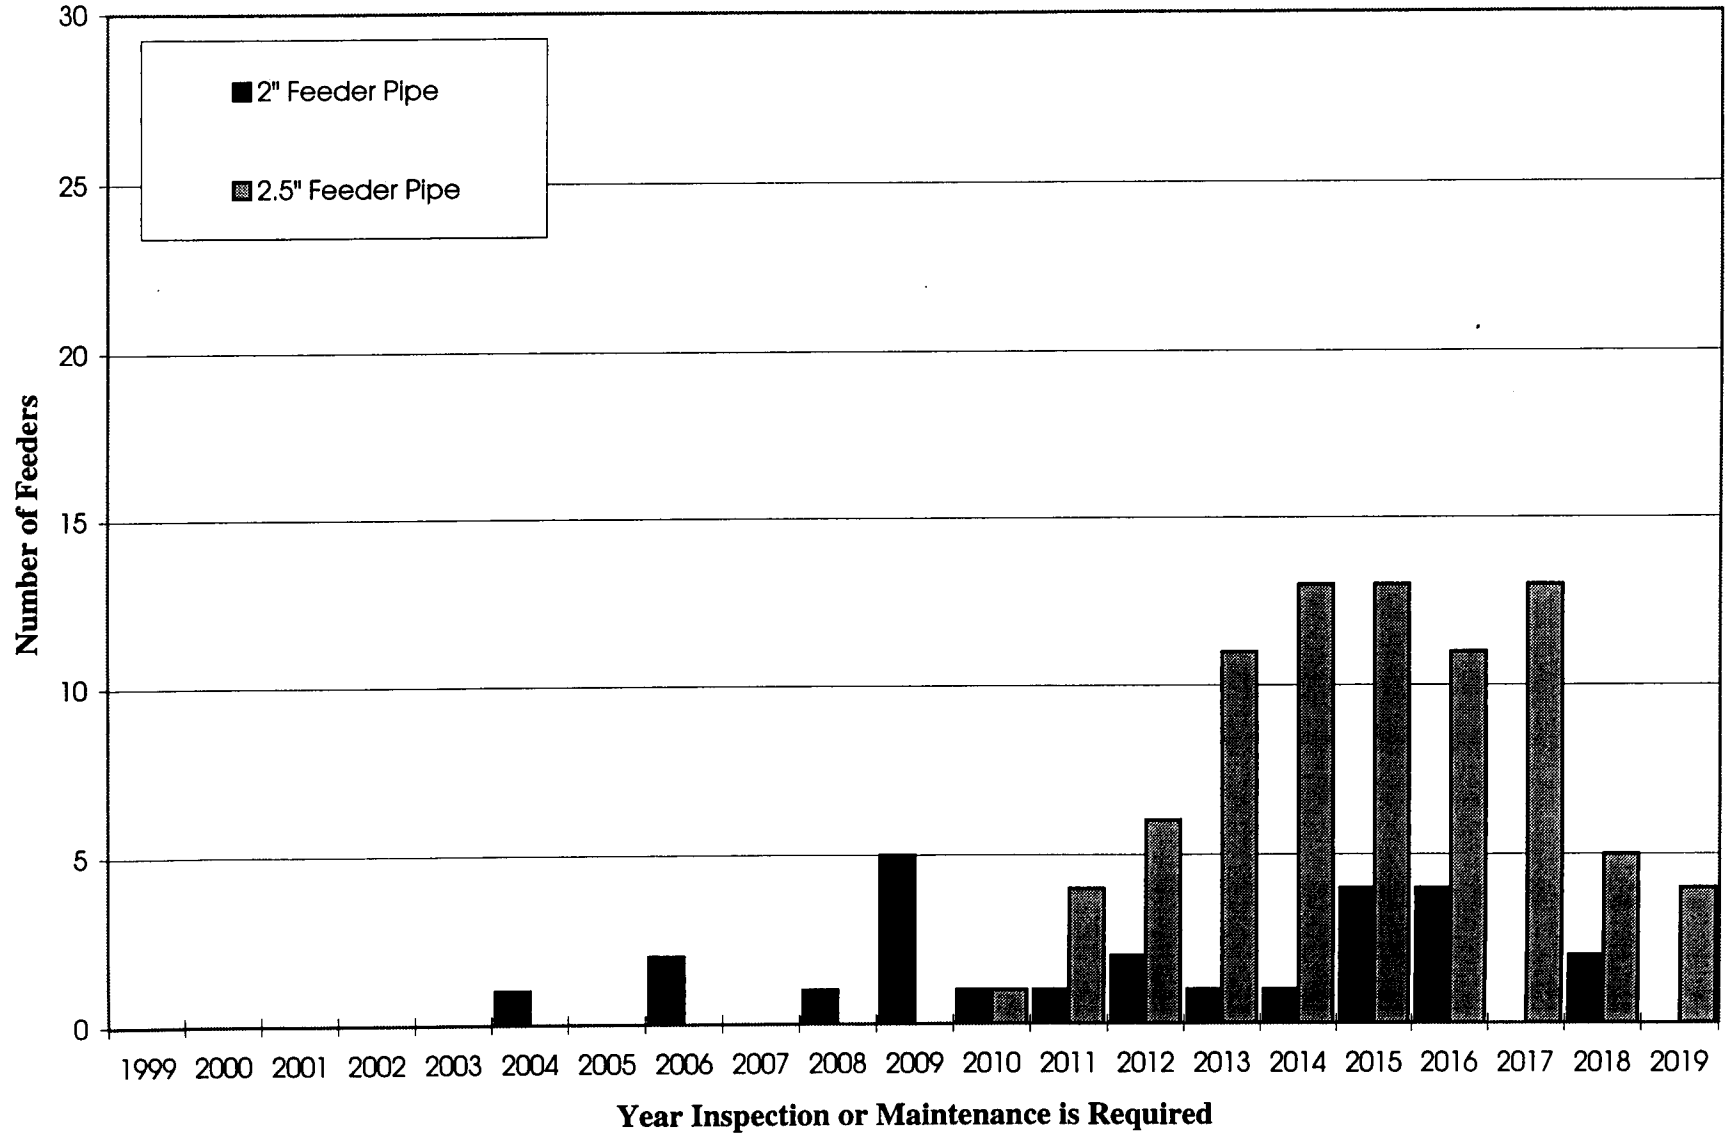
Full Power Years at Shutdown:	13.03 FPY
Number of Feeders Measured this Outage, Baseline:	79 of 175
Number of Feeders Measured this Outage, Repeat:	6 of 7
Total Number Measured, Including Previous Years:	145 of 380

Minimum Measured Thickness for 2" Feeders, Fall '97:	3.53 mm
--	---------

*(Minimum Allowable Thickness is 2.69 mm, the Minimum Measured in 1996 was 3.44 mm)*

Minimum Measured Thickness for 2.5" Feeders, Fall '97:	4.58 mm
--	---------

*(Minimum Allowable Thickness is 3.25 mm, the Minimum Measured in 1996 was 4.71 mm)*
